PHASE I INSPECTION REPORT  
NATIONAL DAM SAFETY PROGRAM

LONE TREE CREEK BASIN  
VAUX #1 AND VAUX #2 DAMS  
SIDNEY, MONTANA  
MT-357 AND MT-358

MORRISON - MAIERLE, INC.

FEBRUARY, 1980

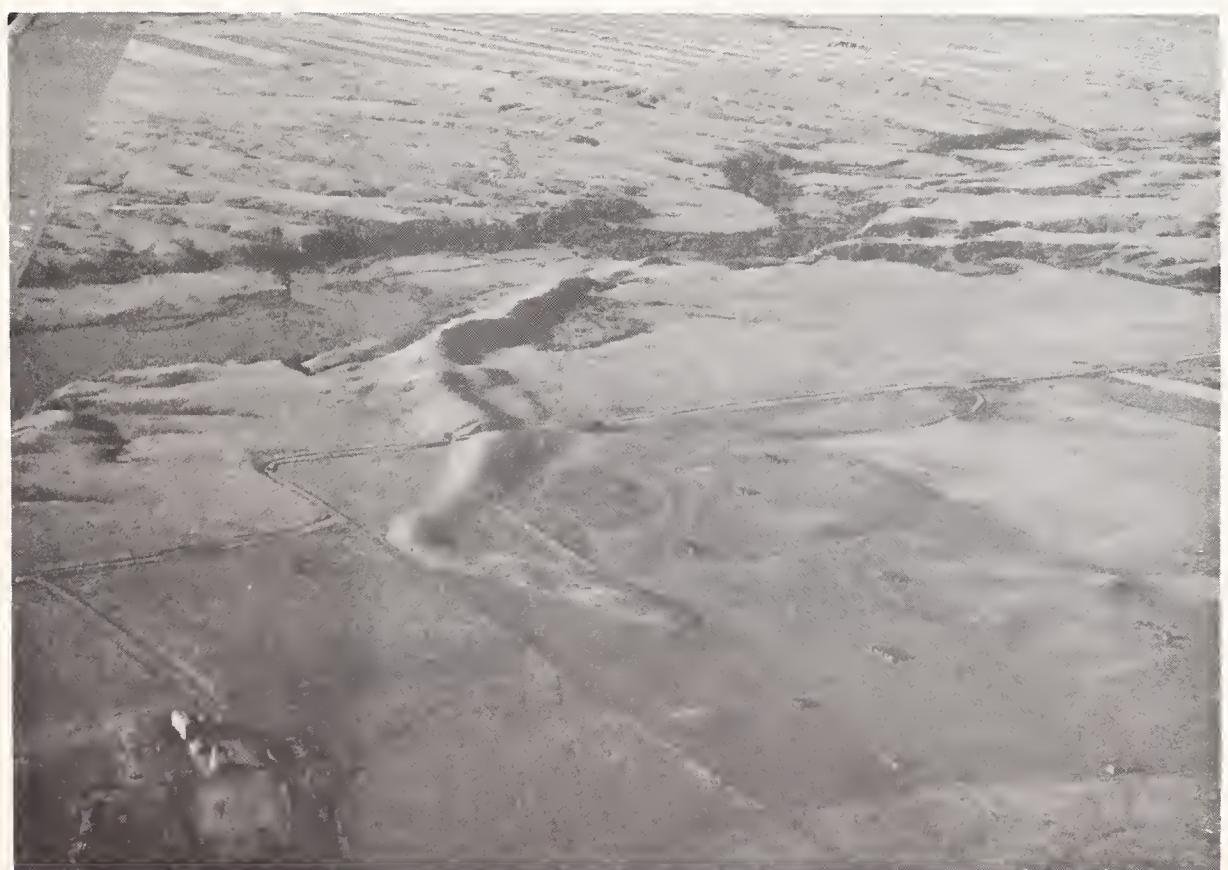
PHOTO 21 VAUX #2 ESKER STANDING ABOVE OUTWASH PLAIN NORTH OF RESERVOIR

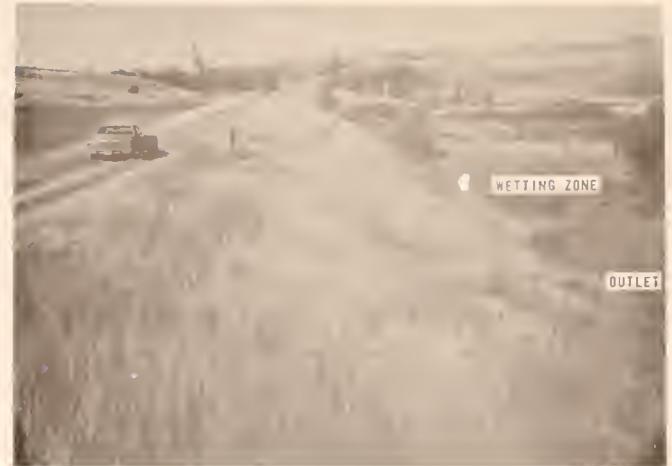
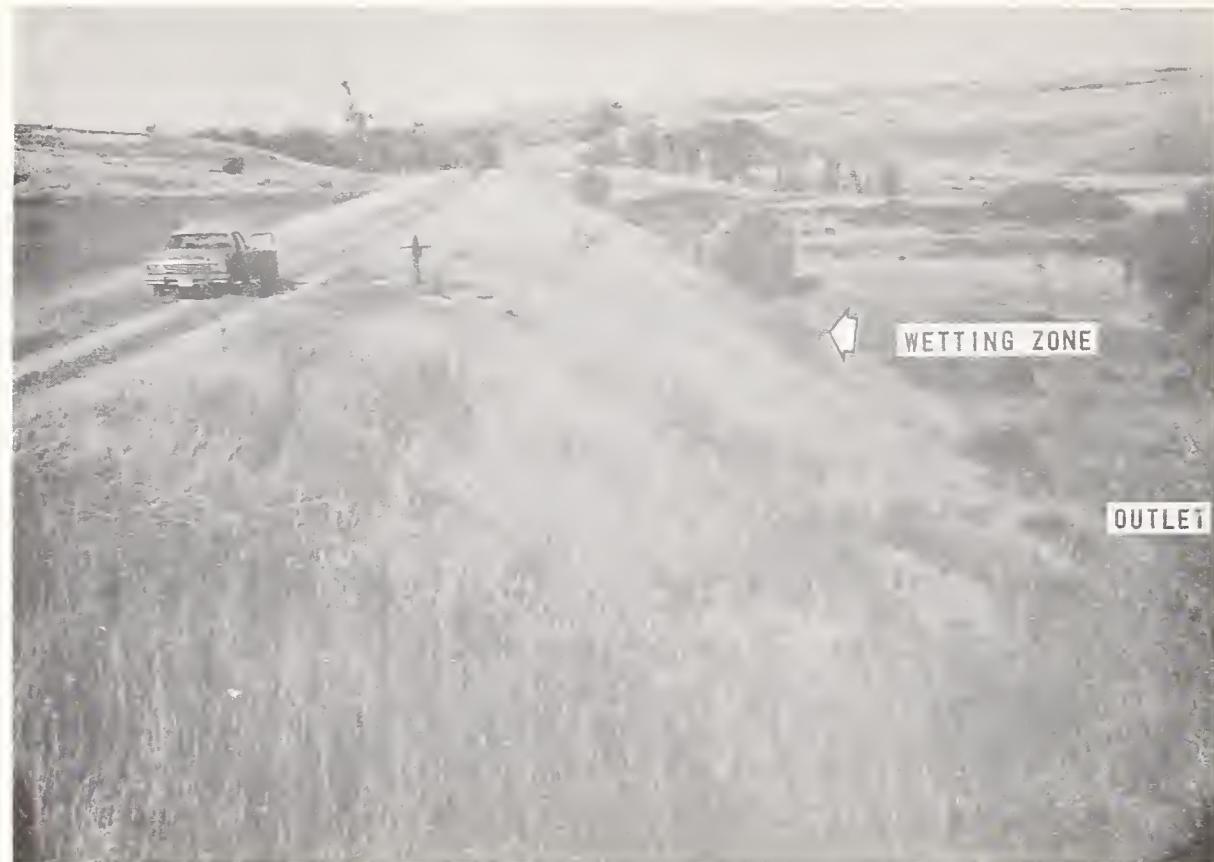
PHOTO 24 VAUX #1 DAM CREST AND DOWNSTREAM FACE FROM SOUTH ABUTMENT

**PHOTO 24 VAUX #1 DAM CREST AND DOWNSTREAM FACE FROM SOUTH ABUTMENT**

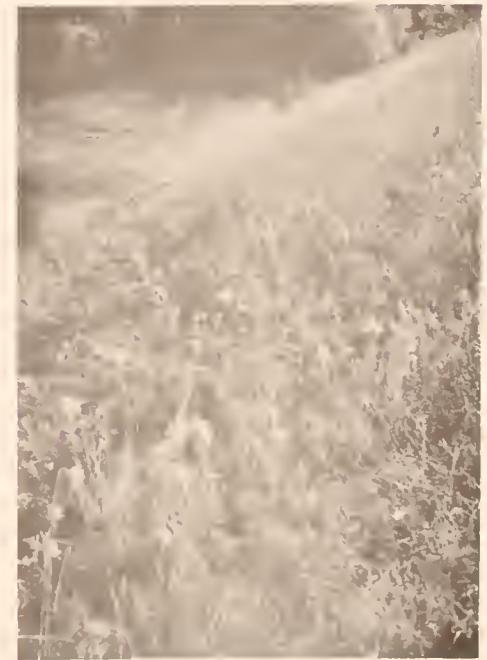
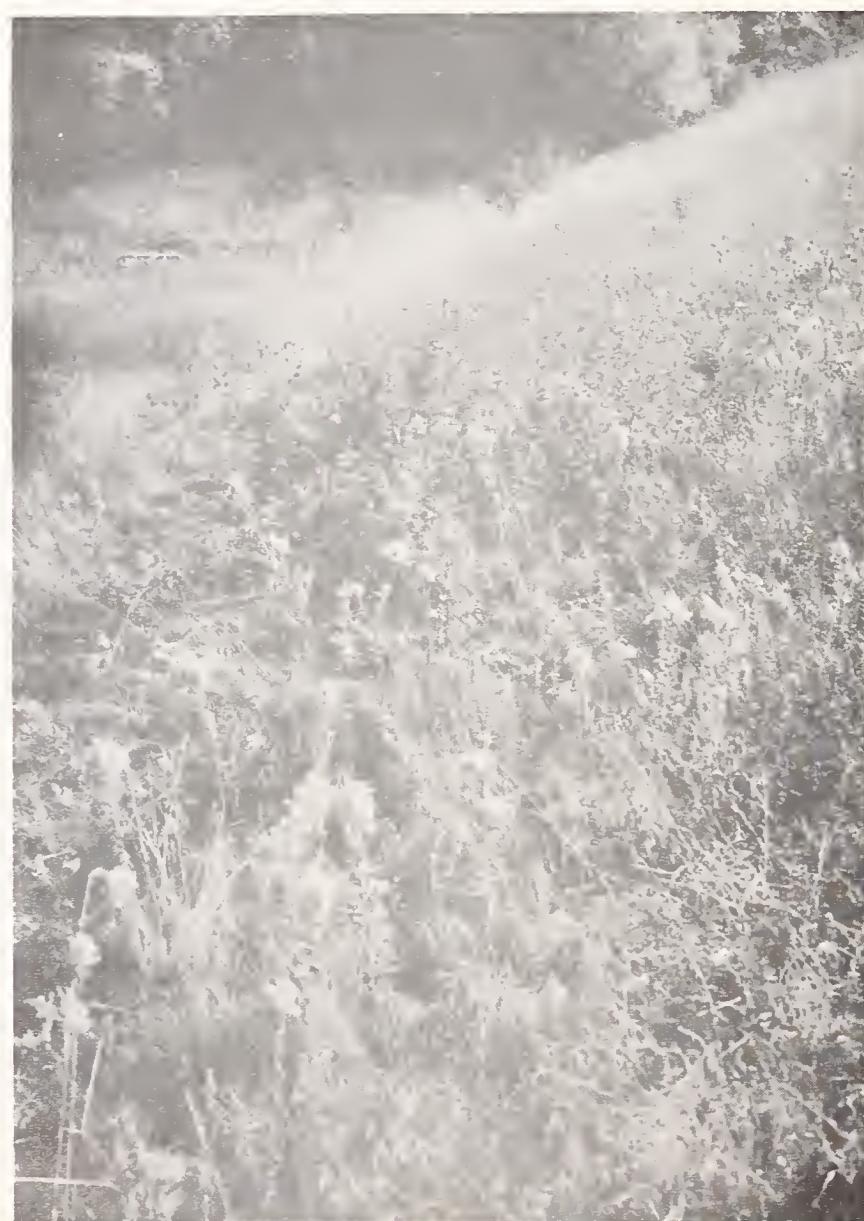
PHOTO 25 VAUX #1 WETTING ZONE ON FACE OF DAM NORTH OF OUTLET

**PHOTO 25 VAUX #1 WETTING ZONE ON FACE OF DAM NORTH OF OUTLET**

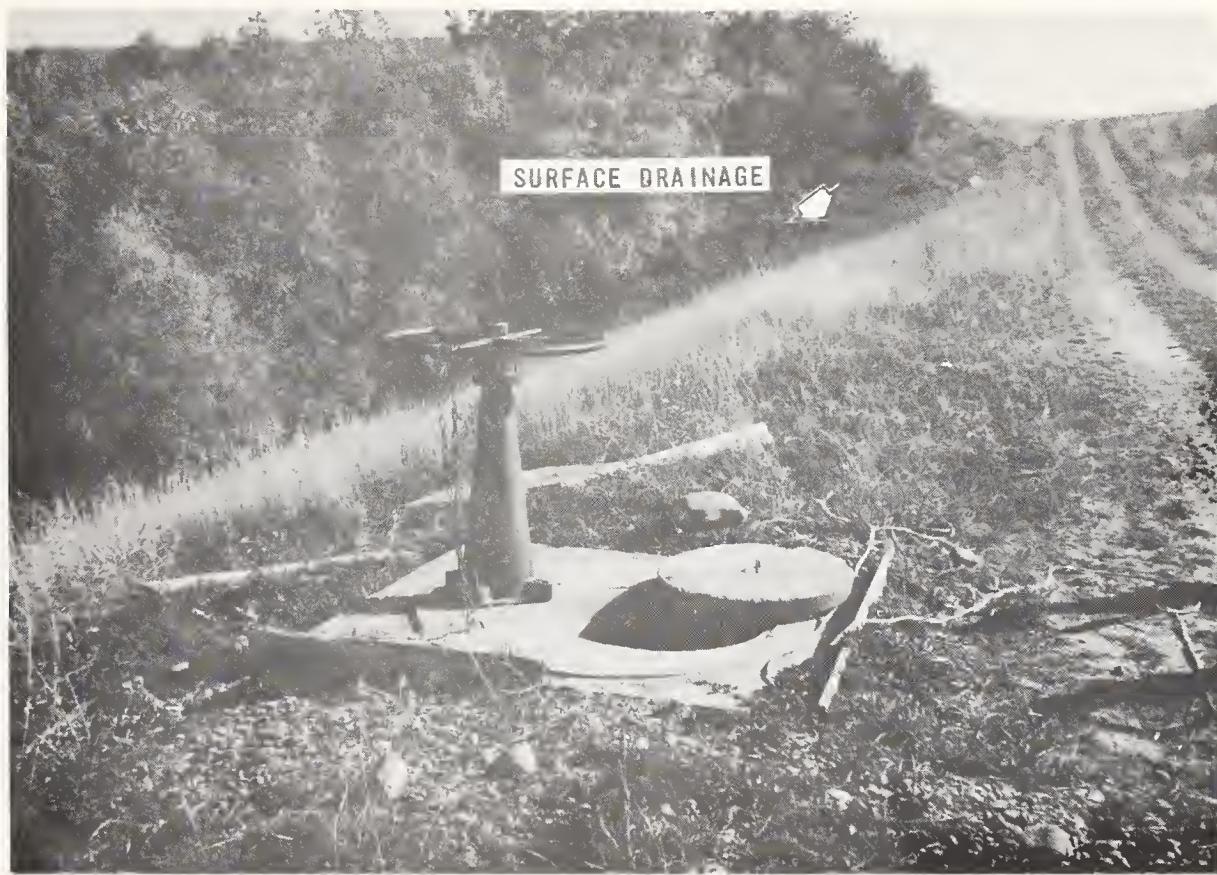
**PHOTO 26 VAUX #1 SOUTH ABUTMENT AND GATE CONTROL**

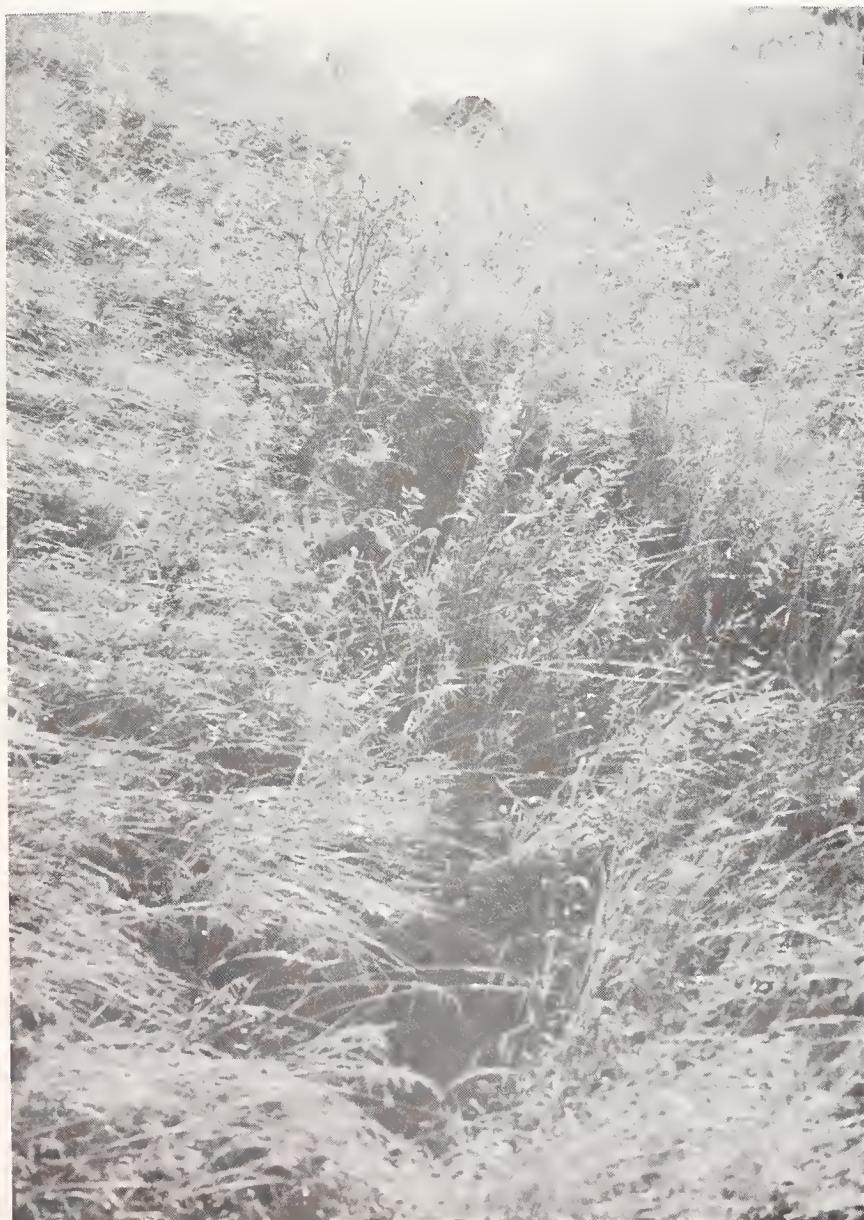
**PHOTO 27 VAUX #1 SURFACE DRAINAGE AT SOUTH ABUTMENT**

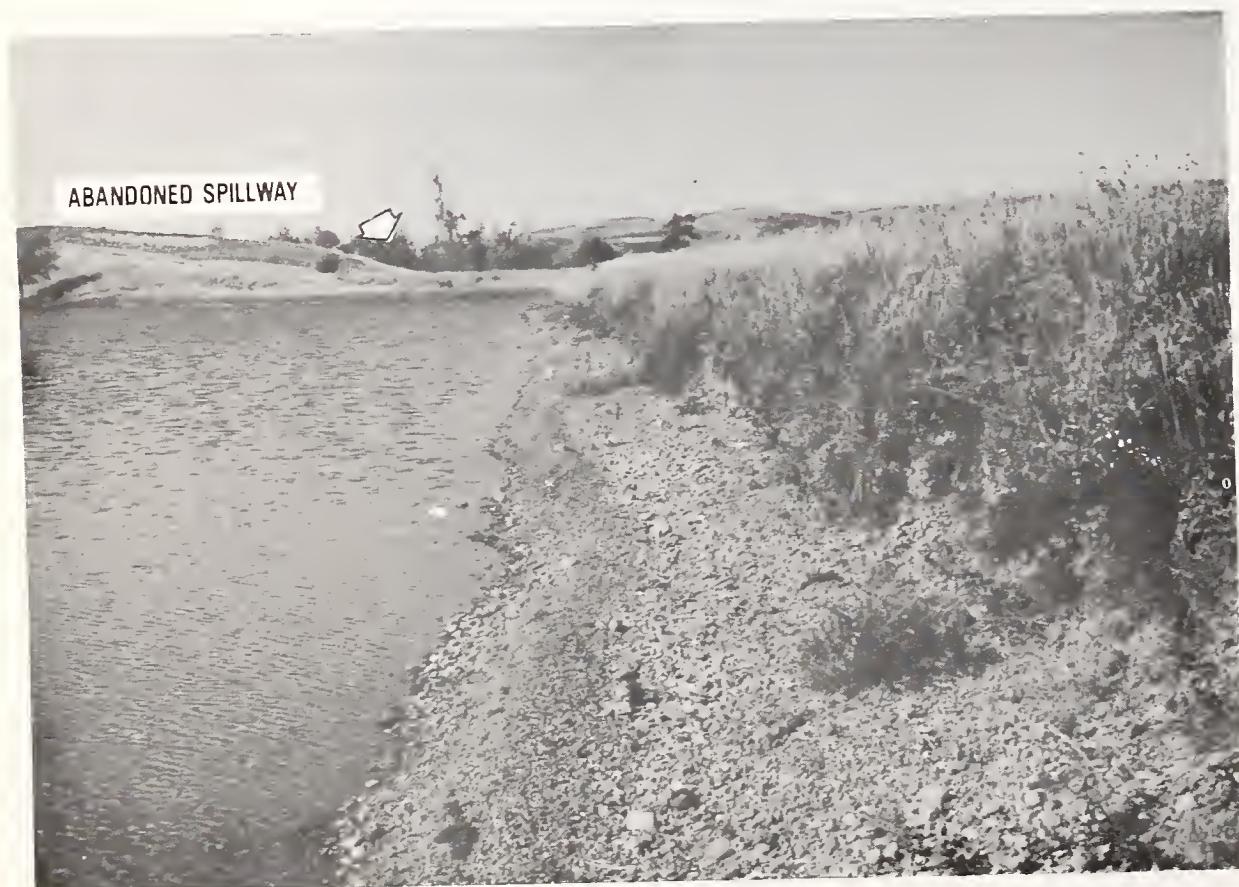
PHOTO 29 VAUX #1 HIGH WATER AND WAVE EROSION ON UPSTREAM FACE TAKEN FROM SOUTH ABUTMENT

- Repair eroded areas of upstream face of embankments and place adequate riprap protection.

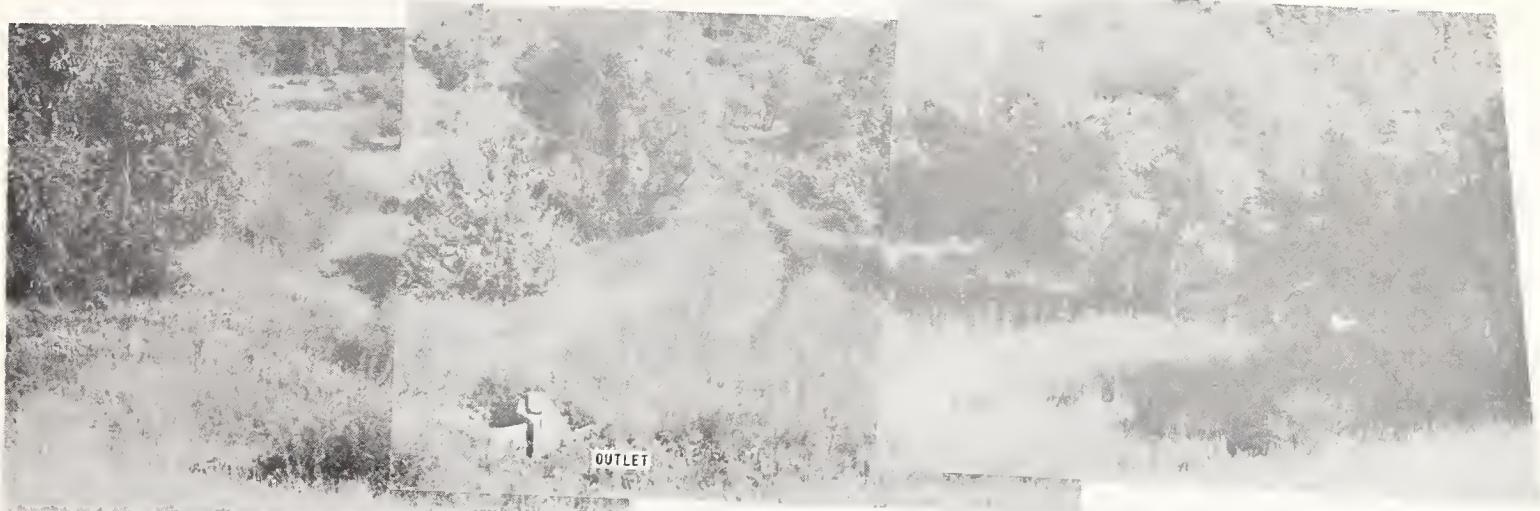
**PHOTO 30 VAUX #1 OUTLET AND DOWNSTREAM CHANNEL NEAR SOUTH ABUTMENT**

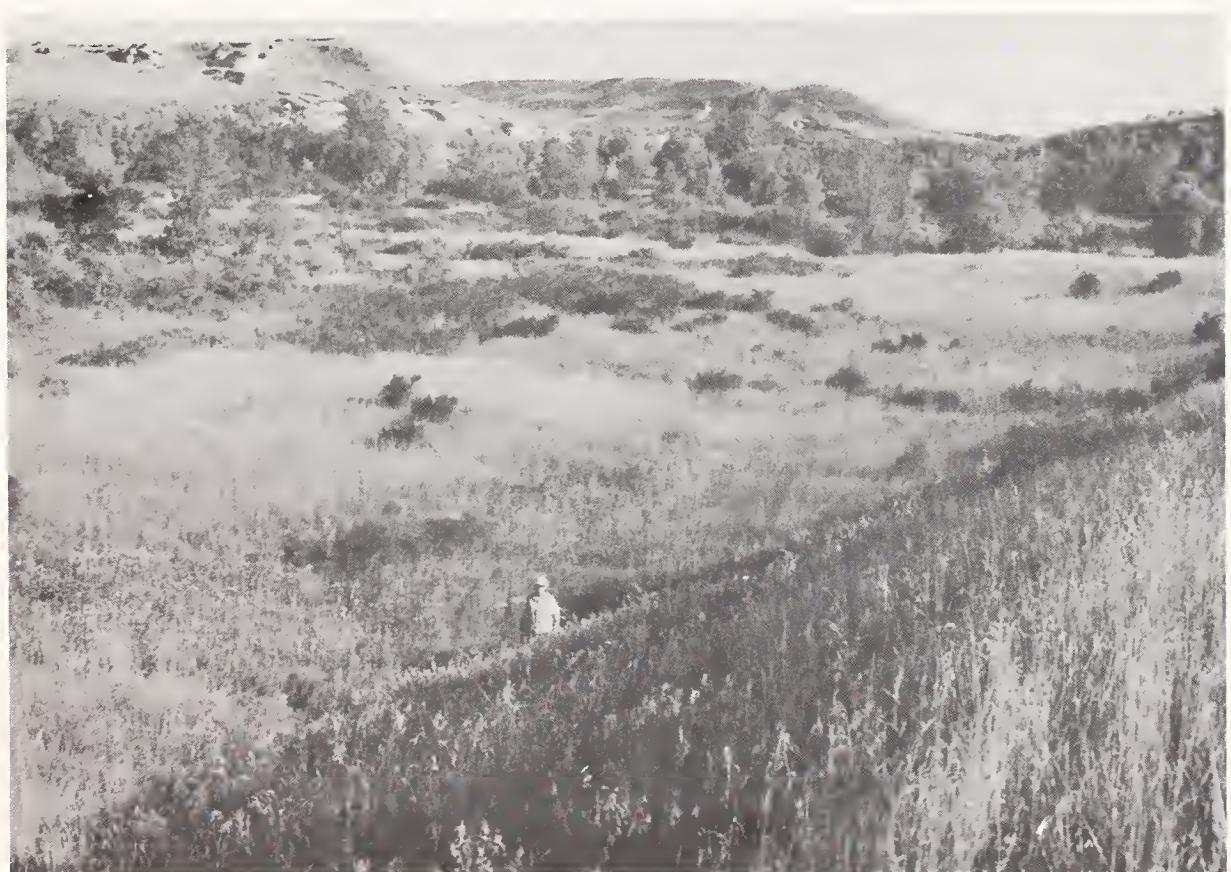
**PHOTO 31 VAUX #1 NORTH ABUTMENT AT CONTACT WITH NATURAL GROUND —  
TAKEN FROM TOP OF DAM**

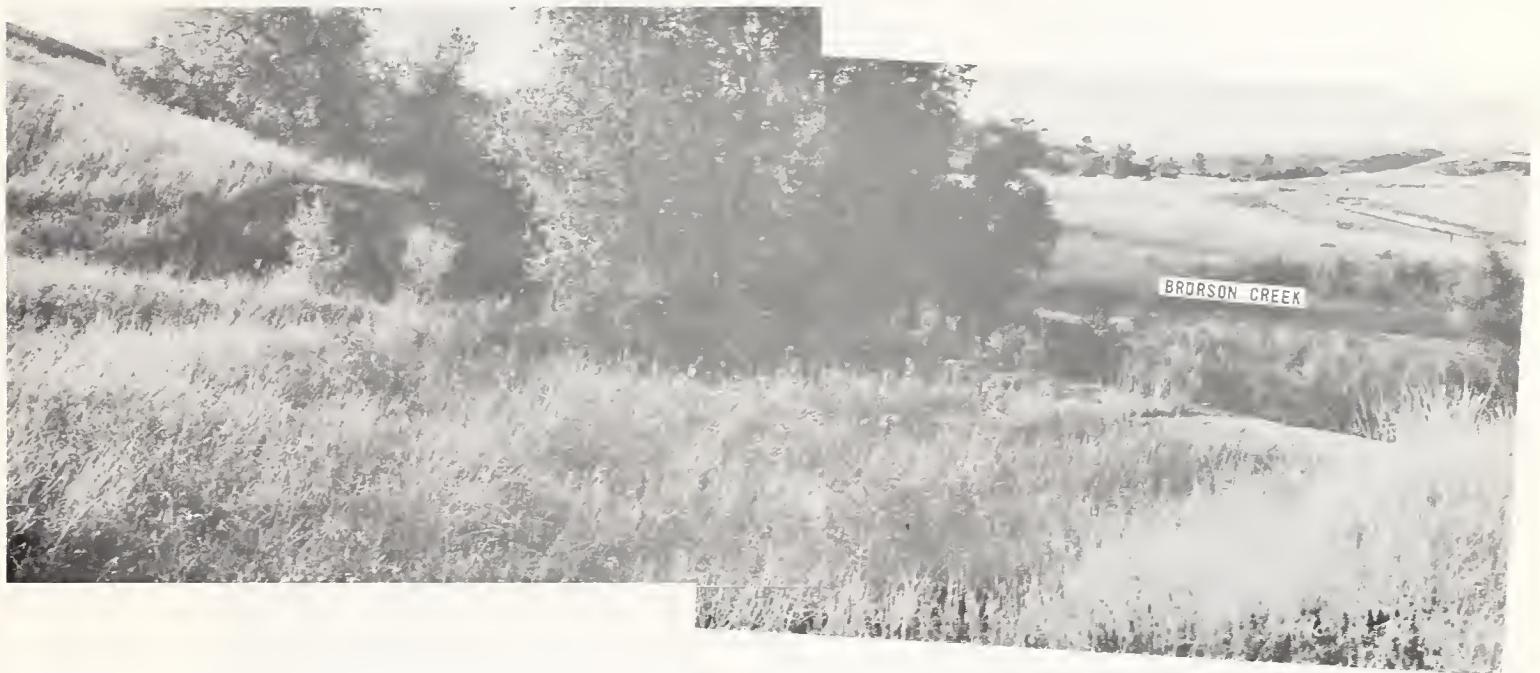
PHOTO 34 VAUX #1 LIP OF ABANDONED SPILLWAY AT DROP TO BRORSON CREEK

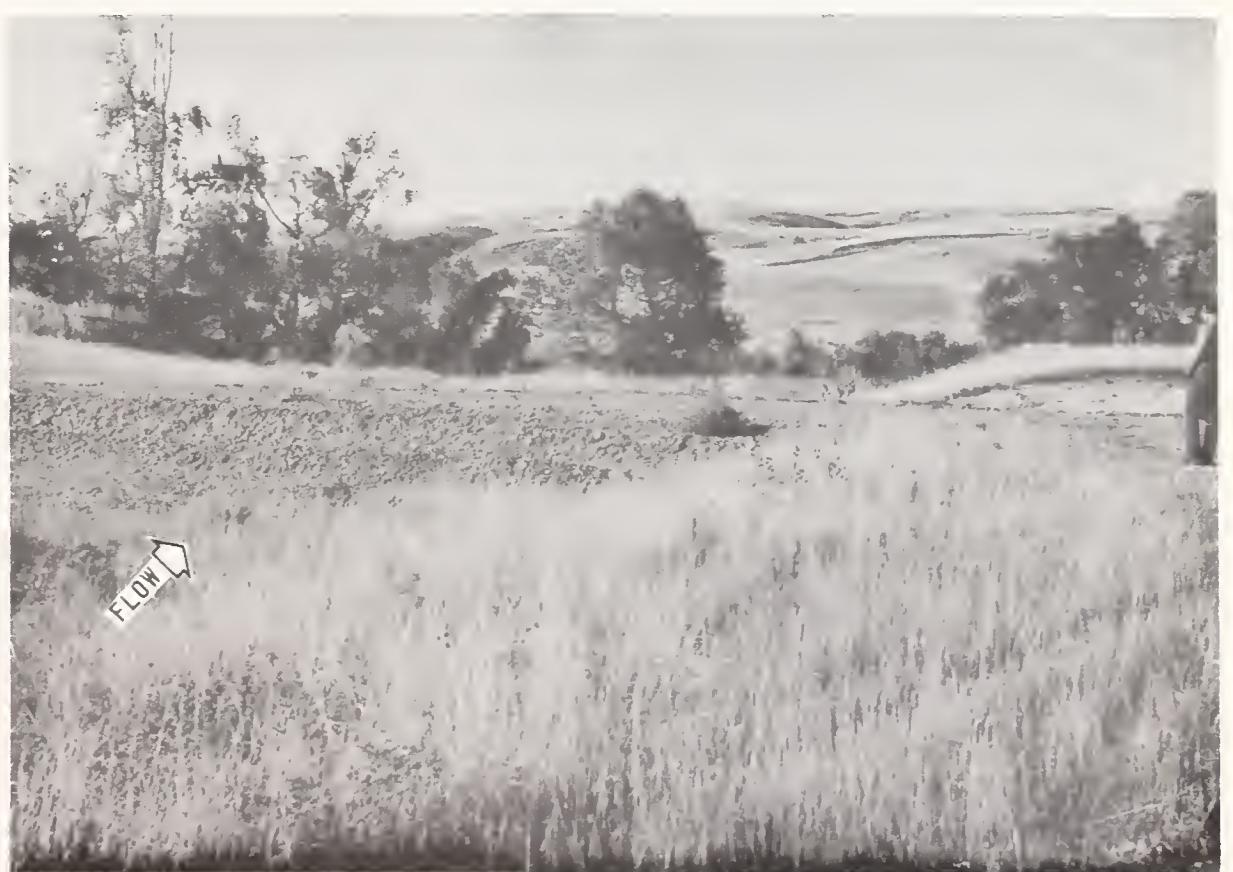
2.2.1.2 Vaux #1 Spillway. An open channel spillway which was constructed with the original dam still exists near the north abutment where it was cut through the natural divide to Brorson Creek (Photo 33). After the construction of the upper dam the spillway at Vaux #1 was abandoned and two earth embankment roads were constructed across the channel. The minimum elevation of the roads is one foot higher than the top of the dam which prevents the spillway from functioning. The spillway channel has a bed width of approximately 100 feet and a maximum bed elevation 4 feet below the crest of the dam. The channel extends 235 feet on a 0.5% slope to a concrete sill and then drops to Brorson Creek. Normal operating pool is seven feet below the crest of the dam, however, high water marks indicate the pool has been operated with five feet of free-board.

PHOTO 33 VAUX #1 ABANDONED SPILLWAY LOOKING DOWNSTREAM

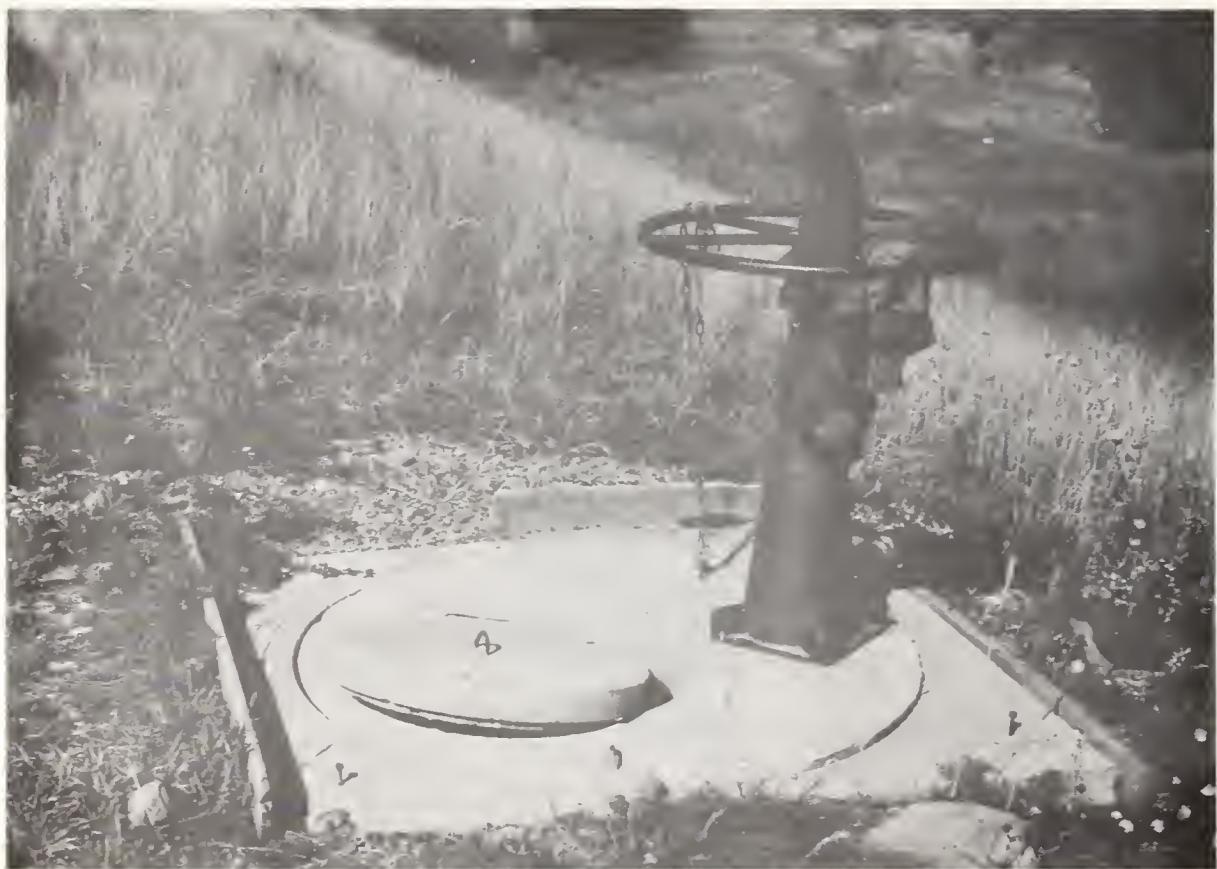
PHOTO 35 VAUX #1 SLIDE GATE CONTROL AND ENTRANCE TO GATE SHAFT

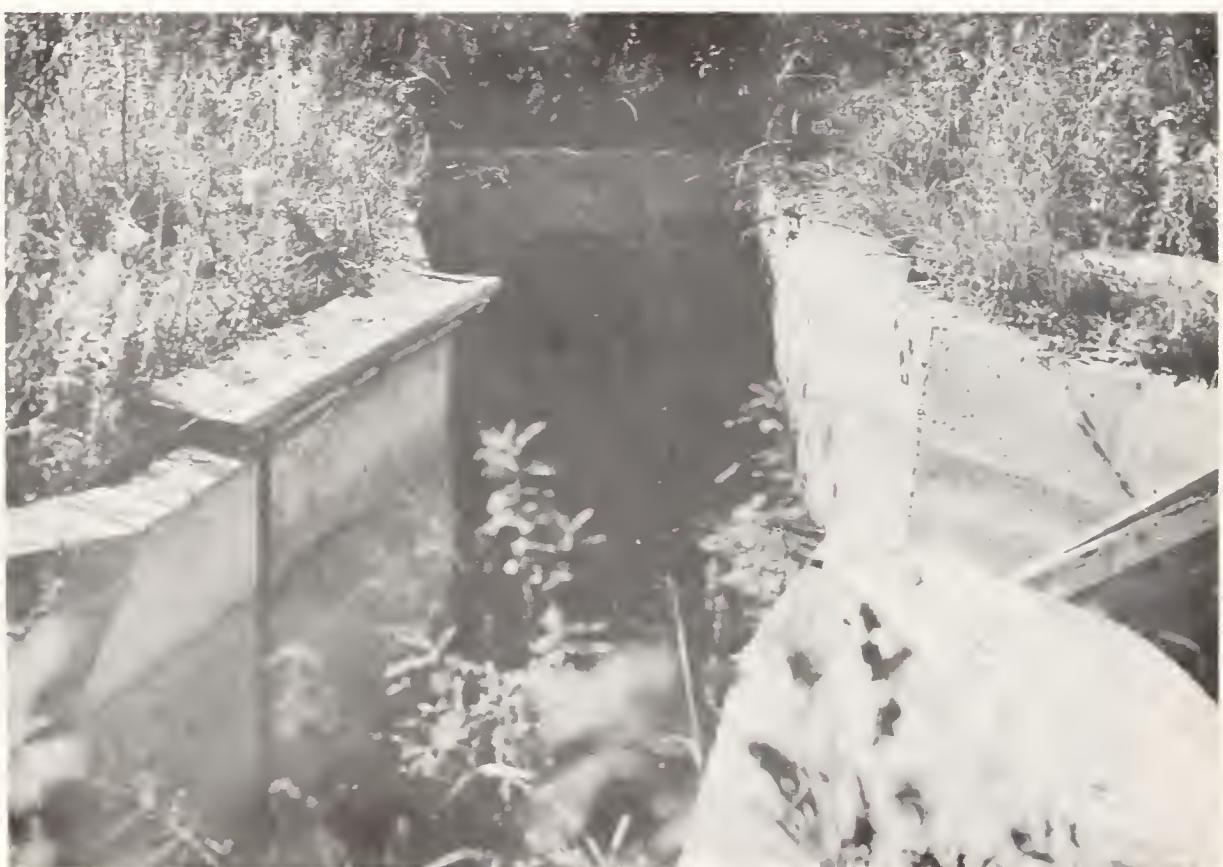
The outlet conduit was inspected at the exit and was in good condition. No concrete deterioration or displacement of joints was observed from the exit, however, the entire conduit was not inspected. The conduit discharges to a flow diversion structure as is shown in photo 36. There is no indication of erosion around the conduit exit. At maximum pool the capacity of the outlet is approximately 50 cfs.

PHOTO 36 VAUX #1 OUTLET AND DIVERSION STRUCTURE
